**RE: Proposed Scope of Work  
Additional Remedial Investigation  
Panelyte Property, Kalamazoo, Kalamazoo County, Michigan**

CITY OF KALAMAZOO  
2403 S. BURDICK STREET, KALAMAZOO, MICHIGAN  
FORMER PANELYTE PROPERTY

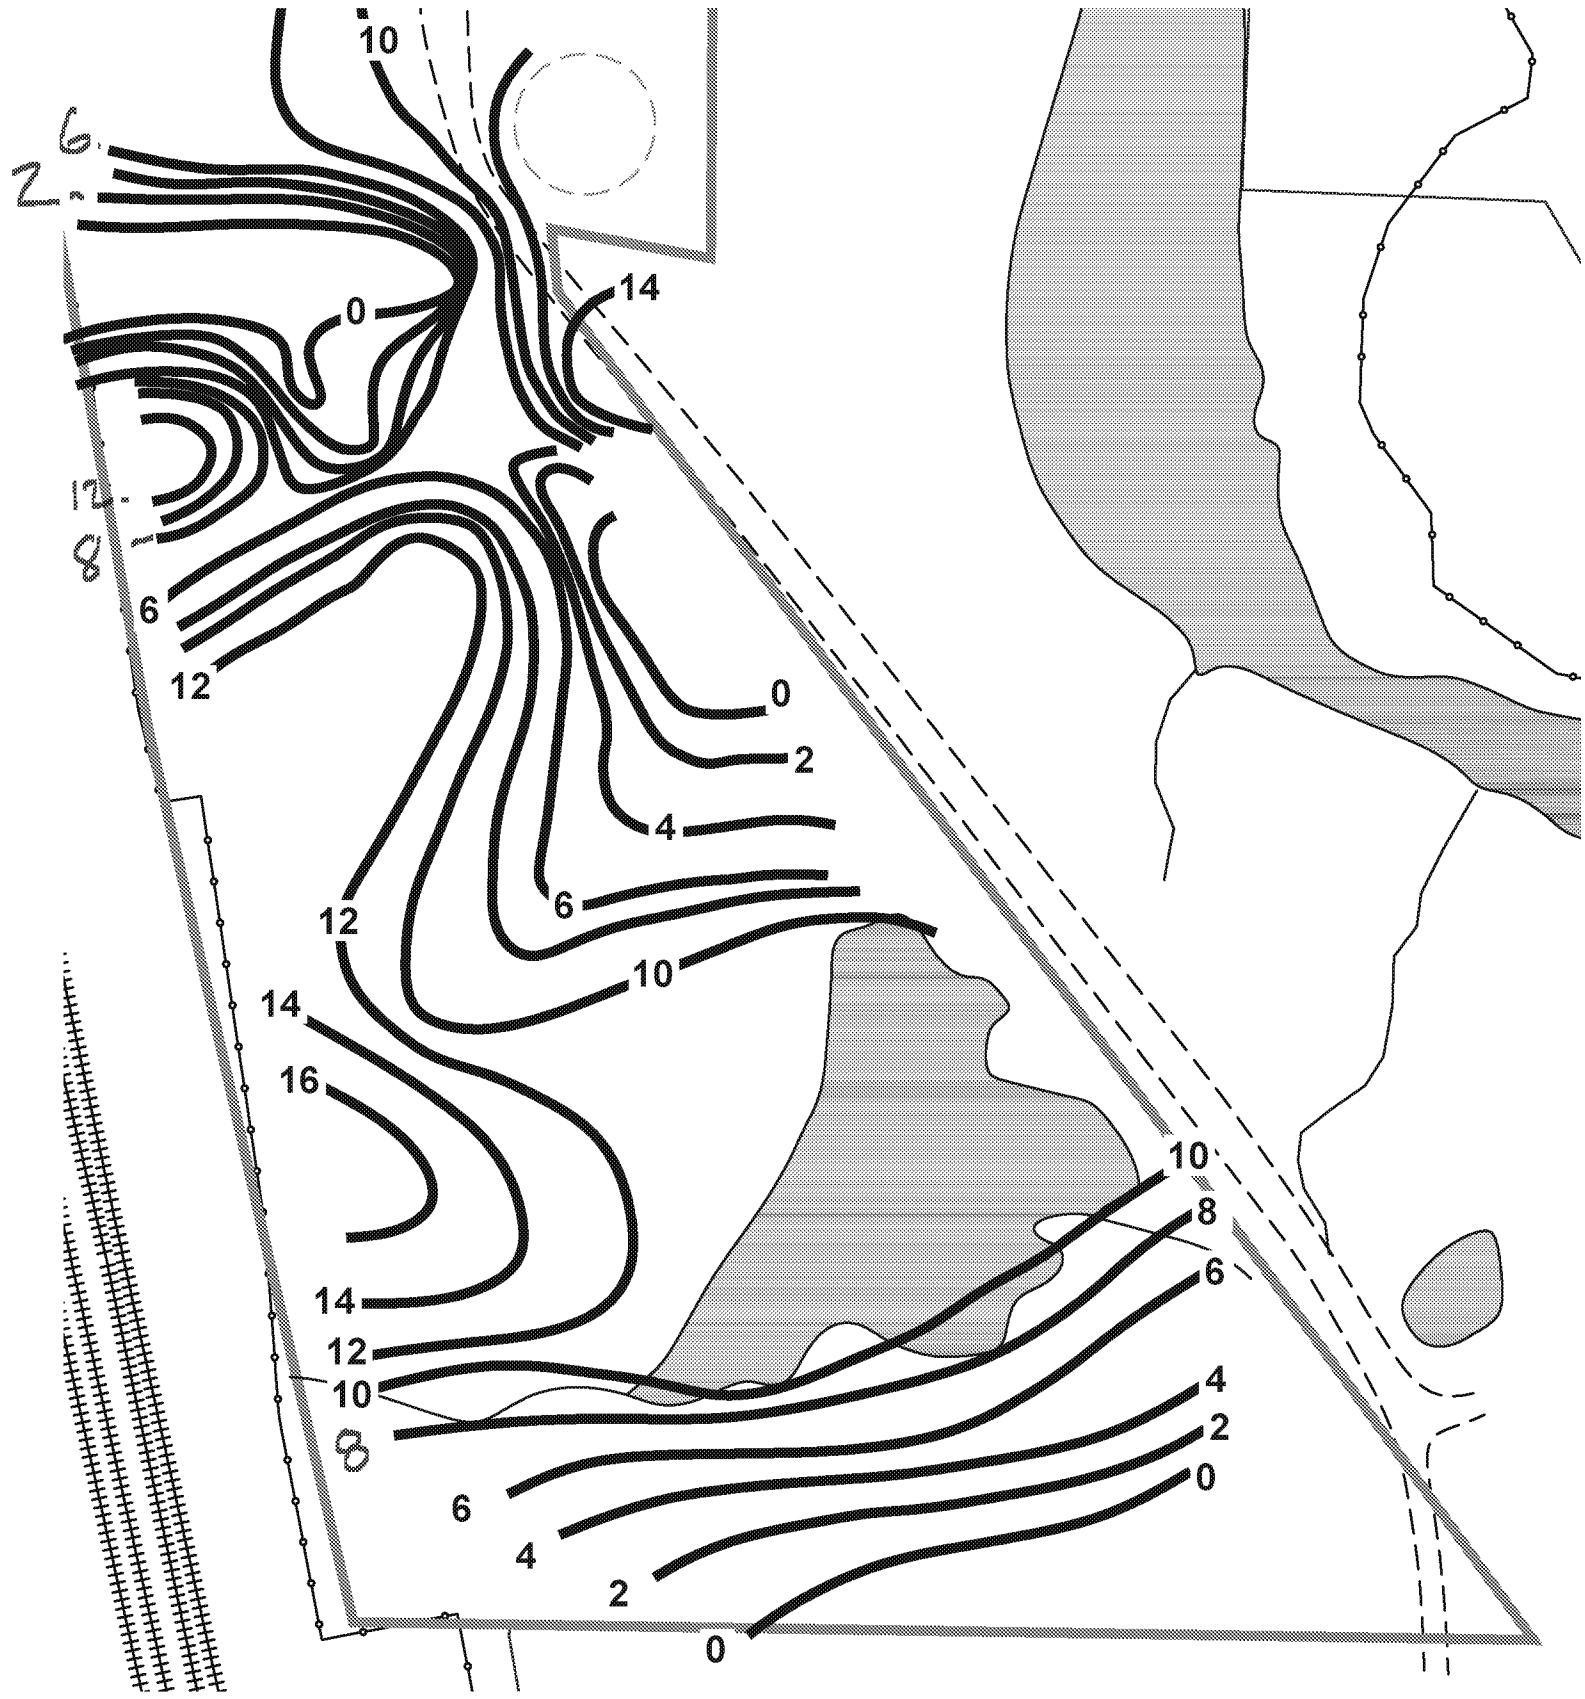
FIGURE 3: PANELYTE DUMP ISOPACH THICKNESS

Numerous borings were installed in the Panelyte Dump Area during the 2004 Landmark investigation to assess the extent of waste materials and the conditions of soil and groundwater. The Landmark investigation data indicates that up to 16 feet of waste material/fill is present in the Panelyte Dump. The estimated extent and thickness of the Panelyte Dump is shown on Figure 3. The Panelyte Marsh is present at the southern end of the Panelyte Dump area. It is likely that waste materials are present beneath all, or portions of, the Panelyte Marsh.
